Charge Gas Compressor Fourth Stage Vibration

Johnny Dugas
Senior Technical Associate
DuPont Sabine River Works
Orange, Texas

Problem

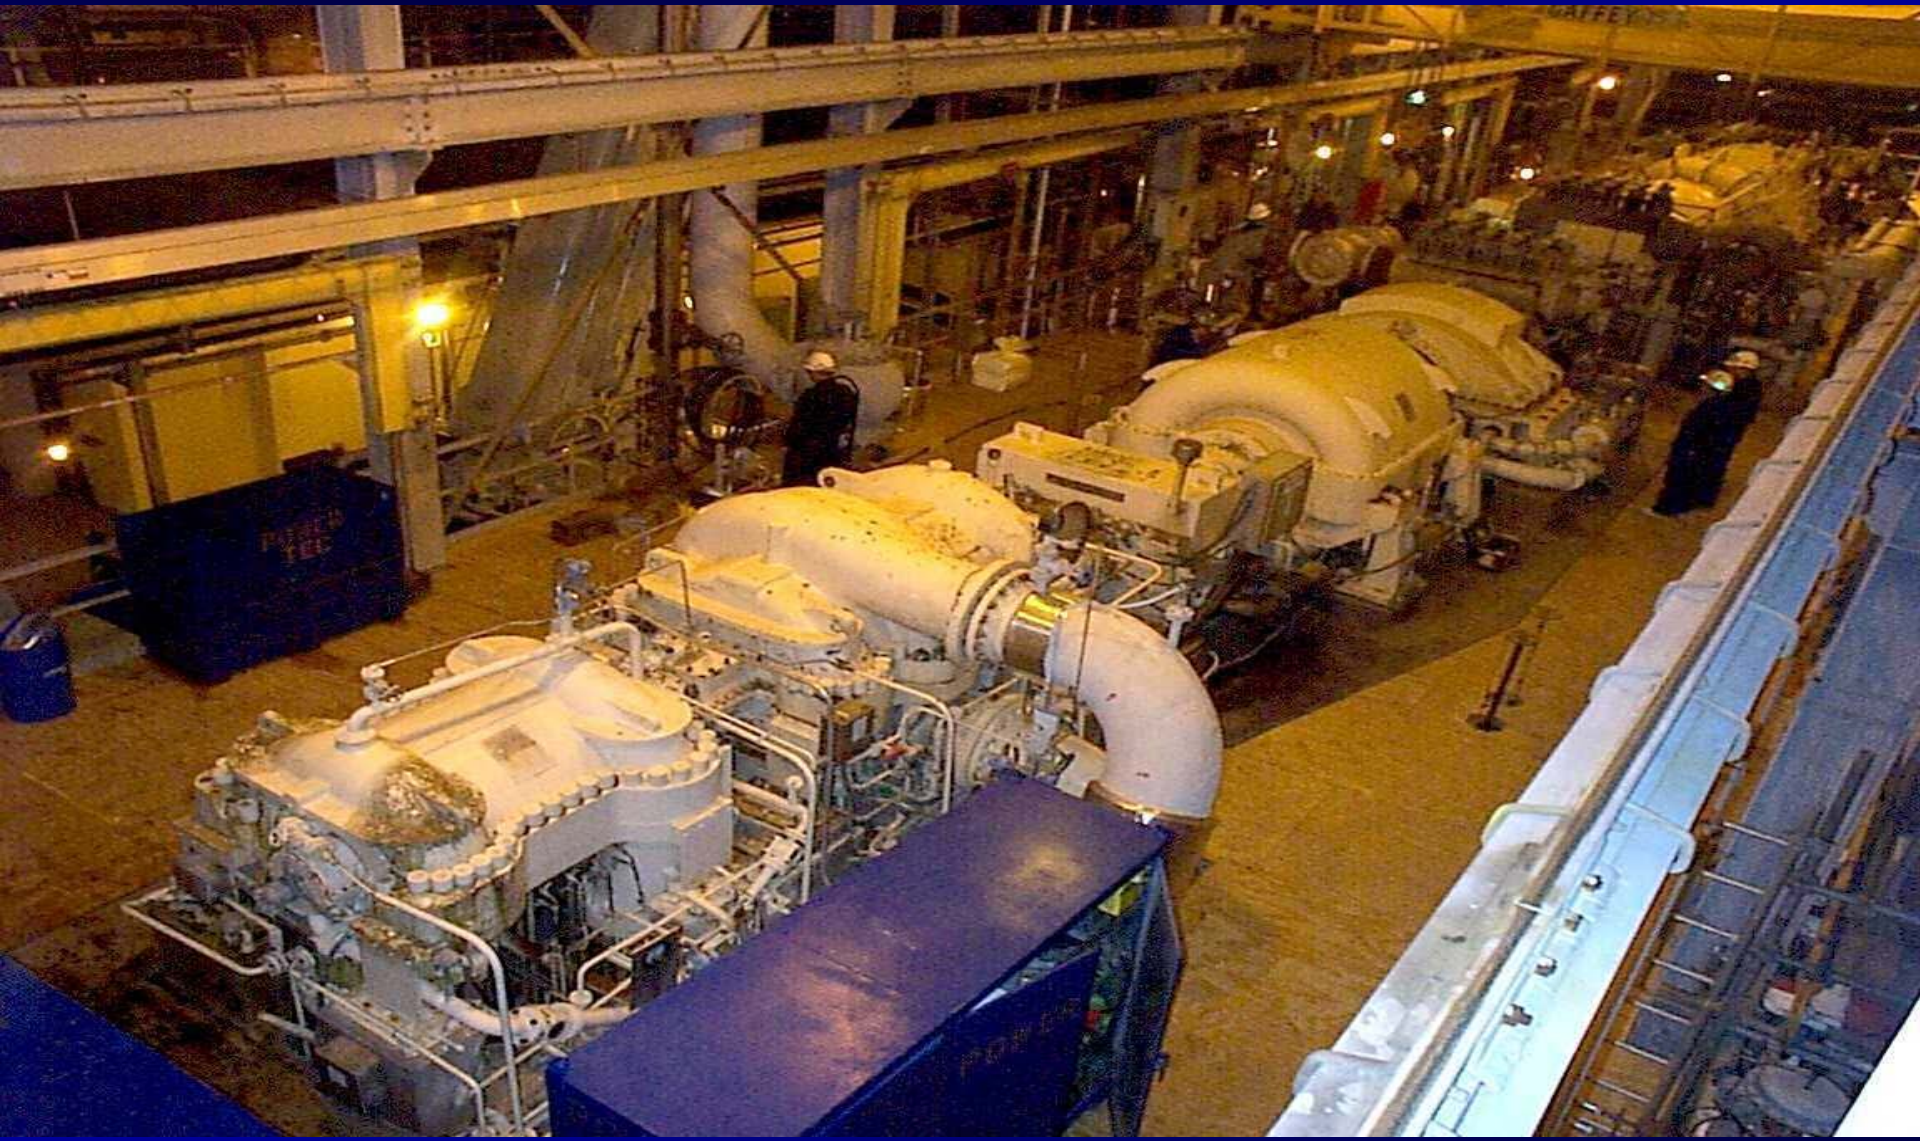
GB201 Compressor Train

- Radial Vibration Spiked to 4 mils Upon Start-up from 2/3 Stage Outage
- Internal Fouling was the Suspected Cause
